TOP 2 BOTTOM HOME INSPECTION REPORT

PROPERTY ADDRESS: 1414 Main Street, Lenexa KS 66219

DATE OF INSPECTION: 1/30/2022

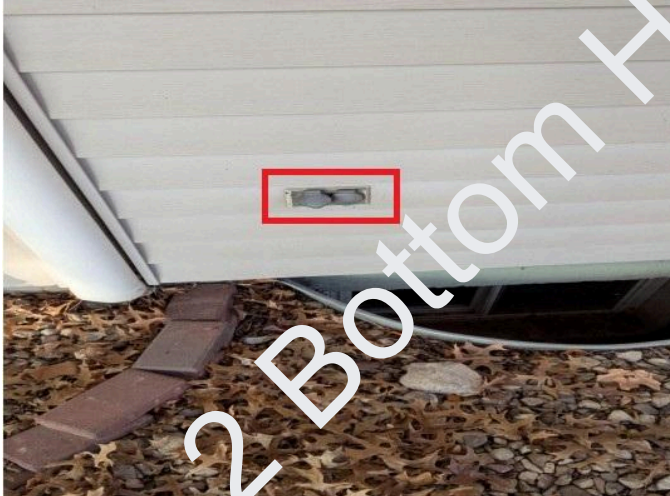
4.4 GFCI Outlet

Major Defect ▾ Observations: I observed that the exterior electrical receptacle at the front of the house is unpowered. Upon further inspection, the associated wiring in the basement has been severed, disconnected from the main panel, and left unsecured. Because the circuit is dead, GFCI protection could not be verified. I recommend that a qualified licensed professional evaluate the circuit and either safely terminate the abandoned wiring in an approved junction box, or repair the circuit and ensure the exterior receptacle is upgraded to provide proper GFCI protection.

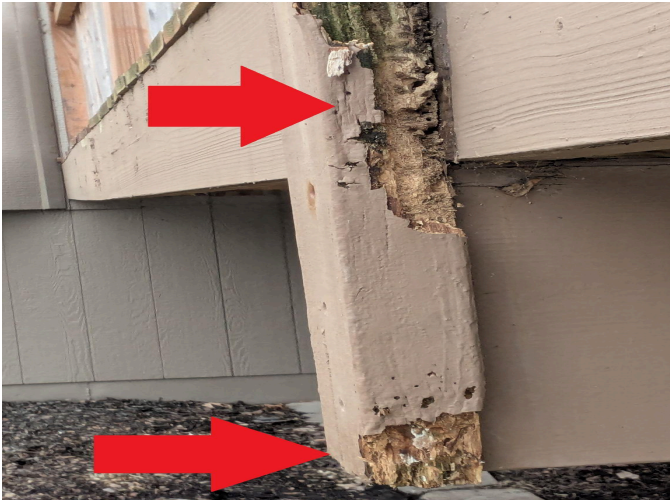
Major Defect - Observations: I observed evidence of termite activity in the wood framing of the backyard deck. It is also noticed that there is visible structural damage to the wood components. It is strongly recommended that a qualified licensed professional be engaged to conduct a comprehensive assessment and implement the necessary corrective measures.

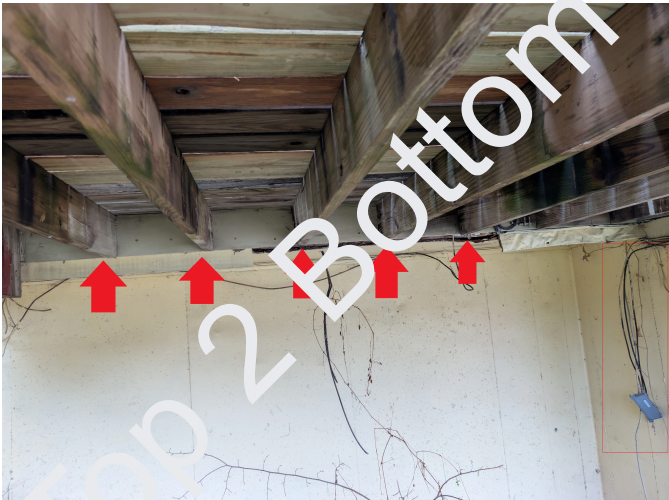
Major Defect - Observations: I observed missing metal joist hangers were observed under the exterior deck framing where the joists connect. It also be noticed that there are unsecured, dangling wires hanging from the structure in the same area. It is strongly recommended that a qualified licensed professional be engaged to conduct a comprehensive assessment and implement the necessary corrective measures.

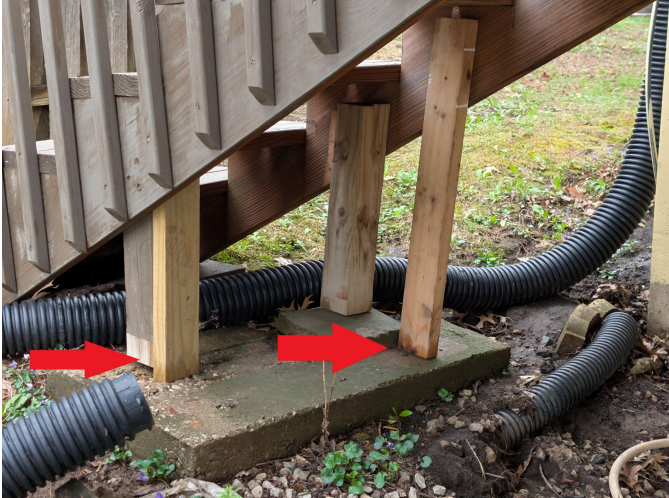
Major Defect - **Observations:** I observed improper, temporary wood supports were observed holding up the exterior deck stairs. It is also noticed that the scrap wood is unanchored and resting directly on loose concrete blocks at ground level. It is strongly recommended that a qualified licensed professional be engaged to conduct a comprehensive assessment and implement the necessary corrective measures.

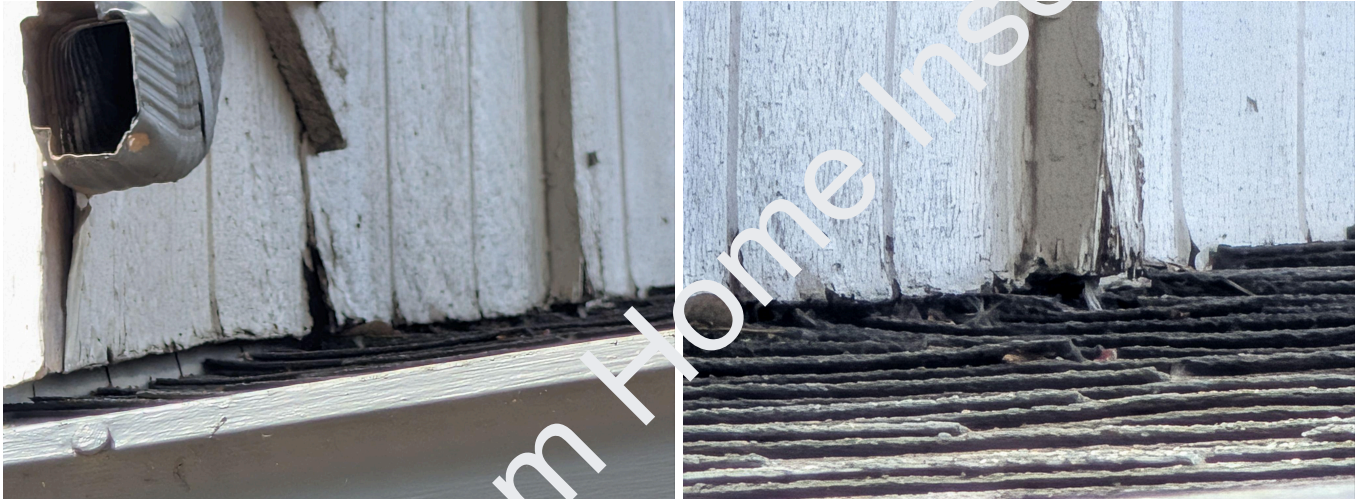
5.2 Sidewall

Major Defect ▾ Observations: I observed severe wood rot was observed in the vertical wood siding where it intersects with the roof surface. It is also noticed that proper metal flashing is missing at this transition and the adjacent roofing materials are heavily deteriorated. It is strongly recommended that a qualified licensed professional be engaged to conduct a comprehensive assessment and implement the necessary corrective measures.

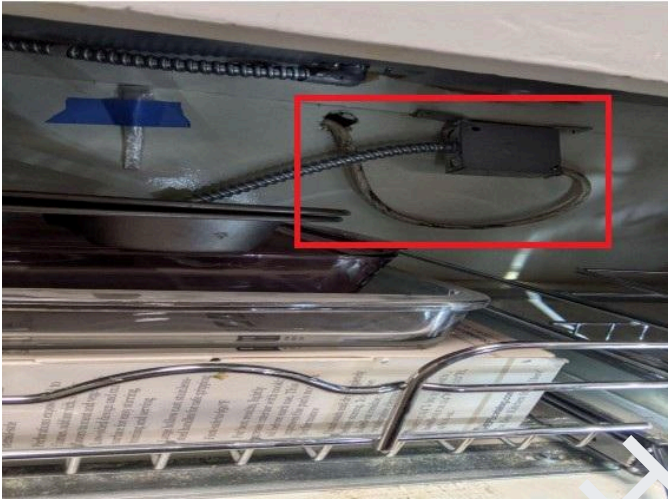
6.1 Stove

Adora ▾ **Major Defect** ▾ **Observations:** I observed exposed electrical wiring within the cabinet located beneath the stove. This placement presents a potential hazard, as the wiring is susceptible to abrasion or damage from items stored in the cabinet. It is recommended that the electrical wiring be enclosed within a protective conduit. Furthermore, it is advised that a qualified licensed professional be contacted for a comprehensive assessment and the implementation of necessary corrective measures.

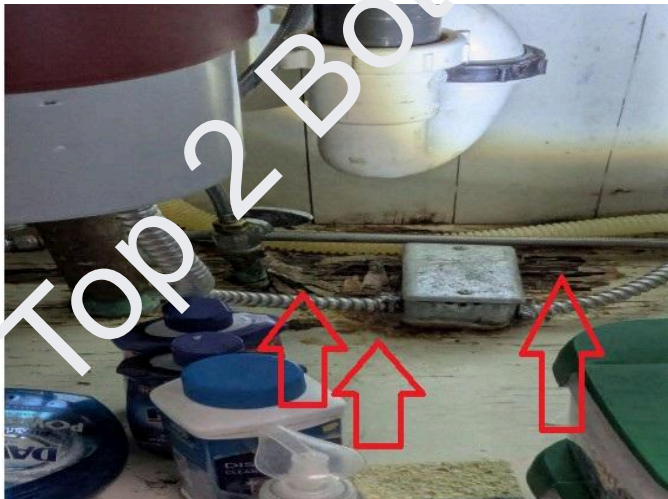
6.2 Sink & Faucet

Major Defect ▾ **Observations:** I observed evidence of previous water damage beneath the sink. No active water leakage was detected at the time of the inspection. It is recommended that further investigation by a qualified licensed professional, specifically by removing the damaged wood to assess for wood rot.

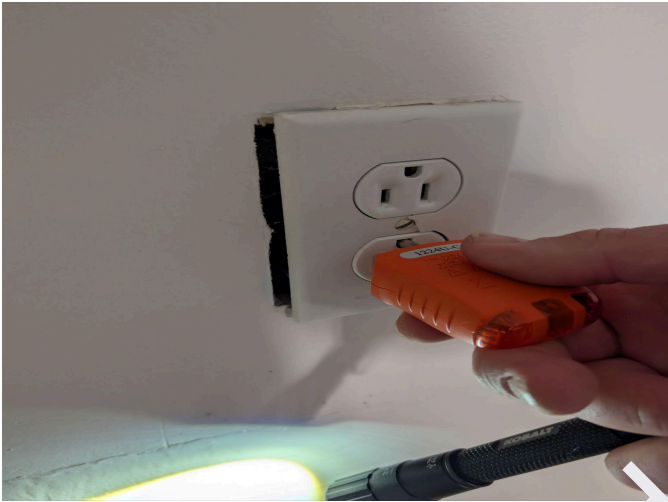
7.1 Lights & Outlets:

Minor Defect - Observations: I observed an outlet cover plate that does not fully cover the wall opening, was observed on an electrical receptacle in the living room. It is also noticed that there is a visible gap exposing the interior wall cavity beside the fixture. It is strongly recommended that a qualified licensed professional be engaged to conduct a comprehensive assessment and implement the necessary corrective measures.

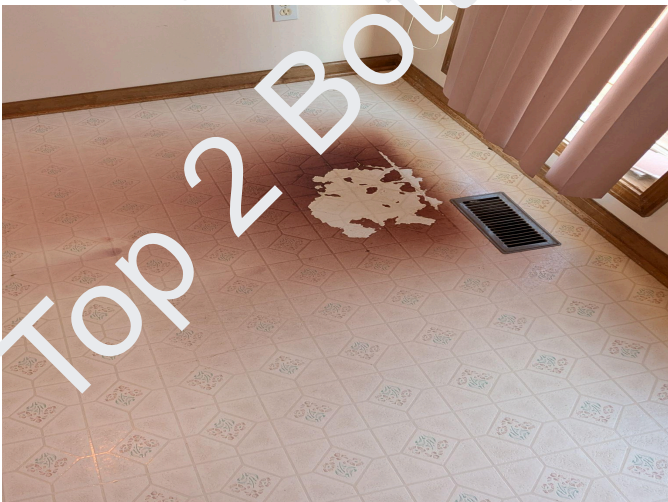
7.2 Floors:

Minor Defect - Observations: I observed a large dark stain and severe surface damage was observed on the flooring in the dining room. It also noticed that the top layer of the flooring is completely peeled away near the floor register. It is strongly recommended that a qualified licensed professional be engaged to conduct a comprehensive assessment and implement the necessary corrective measures.

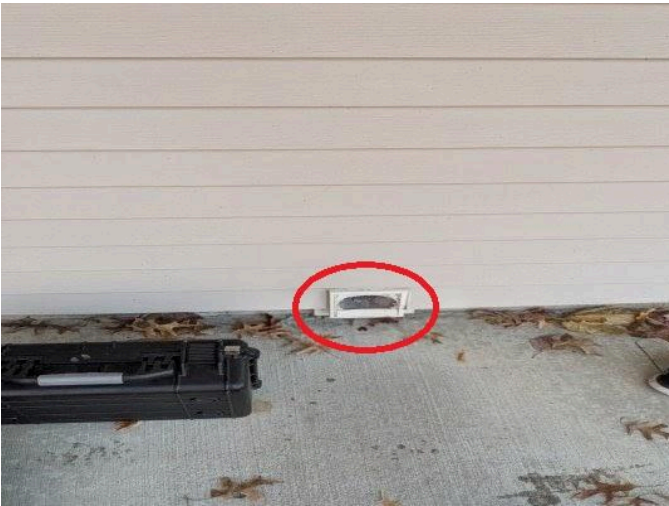
9.1 Dryer Vent (Ventilation/Dryer vent routing)

Major Defect - **Observations:** I observed the exterior dryer vent hood/cover is missing. This condition allows cold air to enter the home and creates a significant entry point for pests and rodents. Recommendation: A qualified licensed professional should install a new, dedicated dryer vent hood with a backdraft damper immediately to prevent animal intrusion.

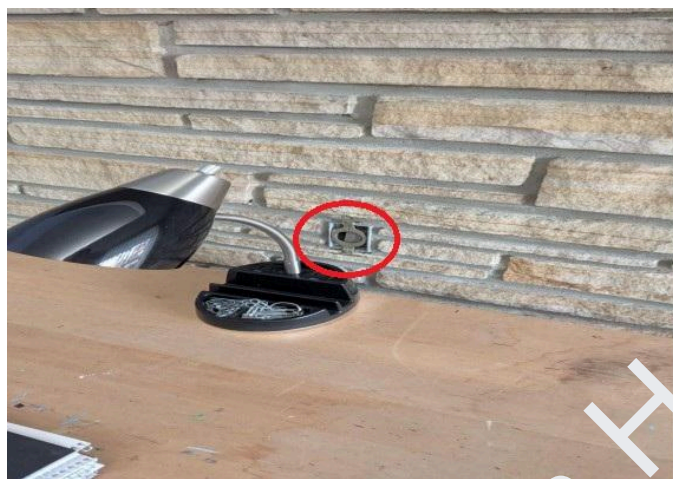
Major Defect ▾ **Observations:** I observed a missing cover plate was observed on an electrical outlet in the bedroom. It also be noticed that exposed wiring is visible. It is strongly recommended that a qualified licensed professional be engaged to conduct a comprehensive assessment and implement the necessary corrective measures.

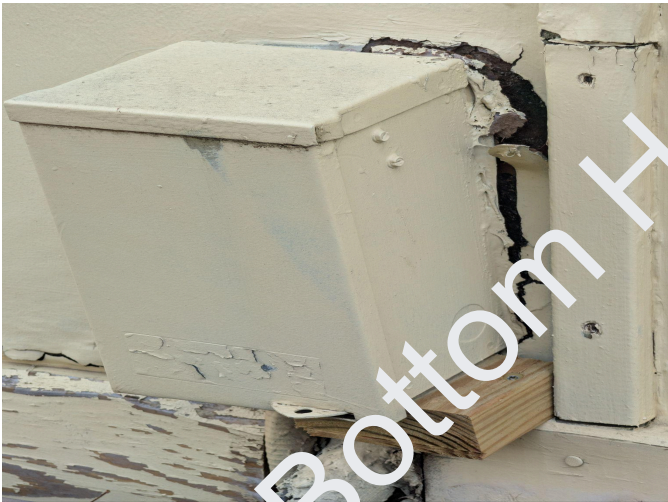
12.3 Exterior Electrical Disconnect Box

Major Defect ▾ **Observations:** I observed an exterior electrical disconnect box pulling away from the exterior siding. It also be noticed that the surrounding sealant has completely failed, revealing significant wood deterioration behind the enclosure, and an improper wooden block has been wedged underneath for support. It is strongly recommended that a qualified licensed professional be engaged to conduct a comprehensive assessment and implement the necessary corrective measures.

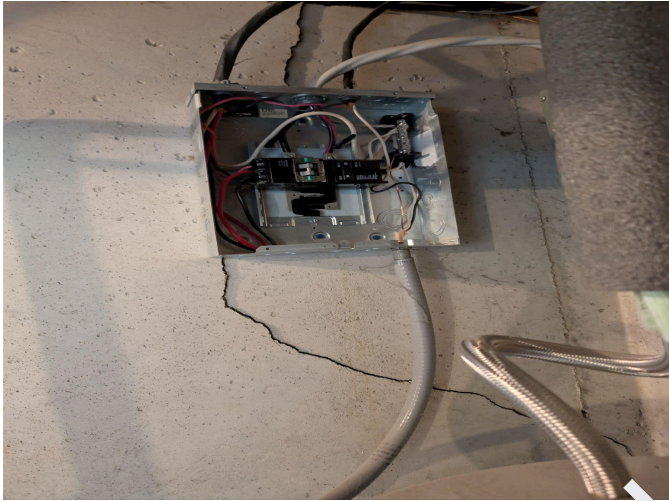
12.4 Main Panel (Location(s), Labeling, Breakers, Clearance, Amp/Volts)

Major Defect **Observations:** I observed a cracked foundation on the north wall of the interior basement. It is also noticed that the electrical sub-panel is not properly mounted on a wooden backboard. It is strongly recommended that a qualified licensed professional be engaged to conduct a comprehensive assessment and implement the necessary corrective measures.

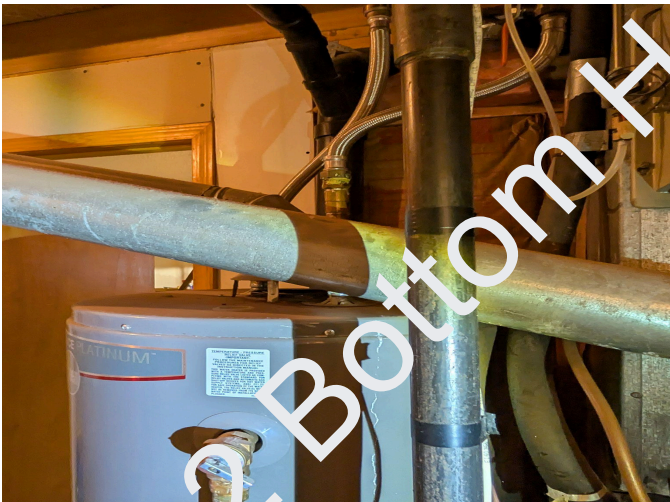
12.11 Expansion Tank

Major Defect ▾ **Observations:** I observed an expansion tank was not observed during the inspection. The installation of an expansion tank is recommended, as it mitigates excess pressure resulting from thermal expansion, thereby safeguarding the plumbing system from potential damage. A qualified licensed professional should be consulted for a comprehensive assessment and to perform the necessary corrective actions.

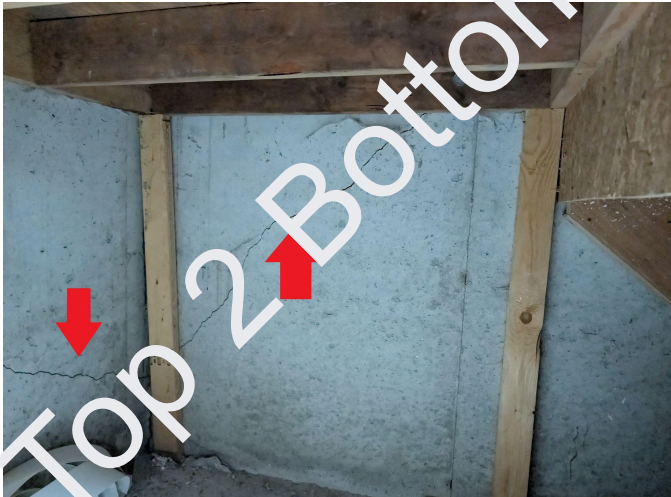
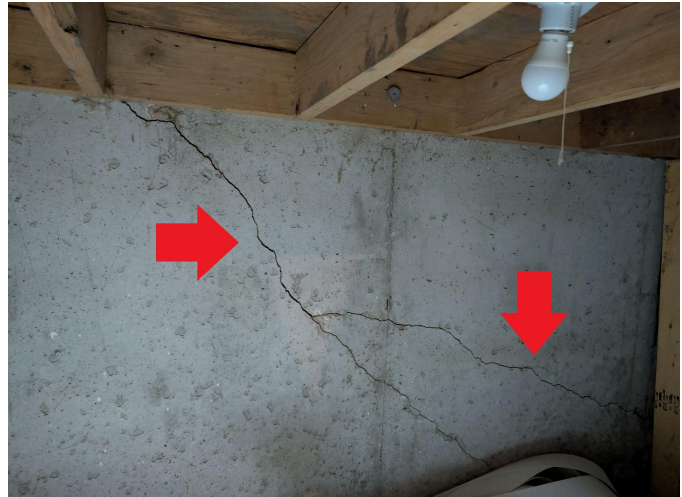
14.6 Foundation Walls

Major Defect ▾ I observed cracking in the foundation on the east and north walls of the interior basement. It also be noticed that these cracks could indicate structural movement or allow for potential moisture intrusion. It is strongly recommended that a qualified licensed professional be engaged to conduct a comprehensive assessment and implement the necessary corrective measures.
